Stelco Hilton Works - PORRI Plant

Hamilton, Ontario

Tank Lining

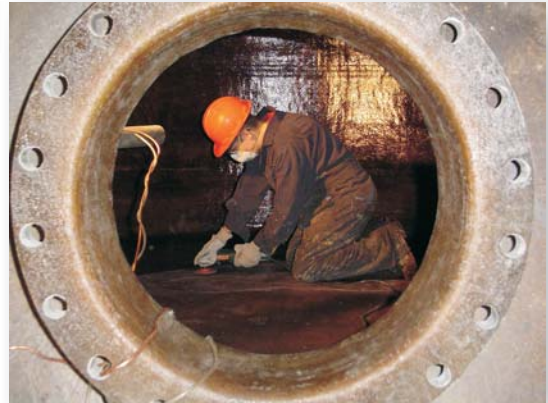
Sanding prior to application of waxcoat

uninterrupted bonding to the substrate. After cure, all surfaces are lightly sanded and inspected for minor defects. A final wax coat is applied to achieve a full cure of the resin system. When completed, the tank is protected by a monolithic, chemical and abrasion resistant liner capable of standing up to the extremely harsh conditions required in the process.

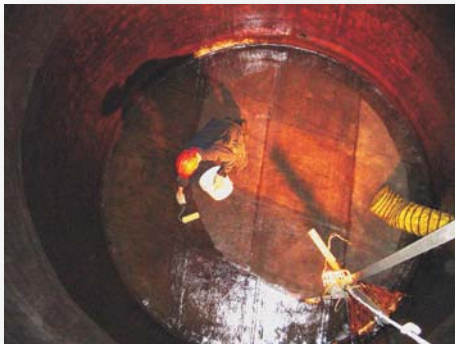
Application of waxcoat - top view
