Burlington Skyway Wastewater Treatment Plant

Burlington, Ontario

Crack Injection

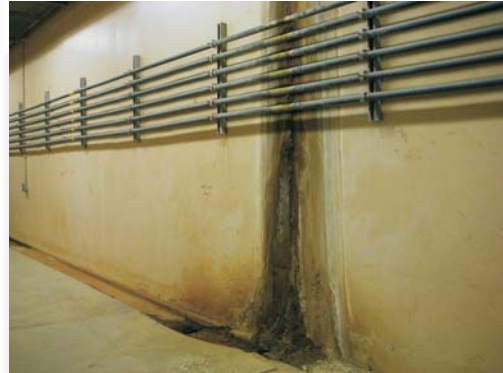
The Regional Municipality of Halton recently began a project to expand, upgrade, and restore the Burlington Skyway Wastewater Treatment Plant to accommodate population growth and to improve the quality of effluent to Hamilton Harbour. One portion of the project included extensive repairs and restoration of the existing concrete floors, walls, and ceilings of the service tunnels running through the plant. Over the years, many settling cracks had developed and some were leaking process water into the tunnels, creating an unpleasant and unsafe environment for plant operators.

Leaking crack in wall

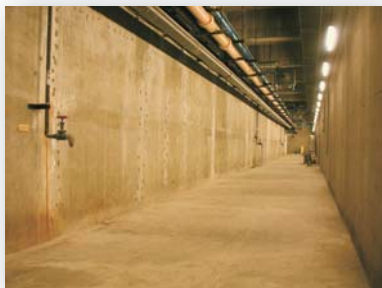
Walls dry after crack injection

- Holes are drilled at 45° to intercept the crack at a depth of one half the thickness of the wall or floor slab.
- Plastic injection packers are installed in the holes.
- Cracks are flushed out with a mild acidic solution and then re-flushed with clean water to remove any residue.
- A water-reactive polyurethane resin is then injected under pressure until it appears at the surface of the crack or at an adjacent port, thus indicating acceptable travel.
- Injection packers are removed and the holes patched.

The success of polyurethane crack injection for leak control depends heavily on proper preparation, product knowledge, and an experienced operator who knows when the crack has received the proper amount of resin. Inscan employs some of the most experienced crack injection experts in the industry and has earned the reputation of being a leader in the field.
