Bruce Power Nuclear Generating Facility

Secondary Containment Membrane

Problem

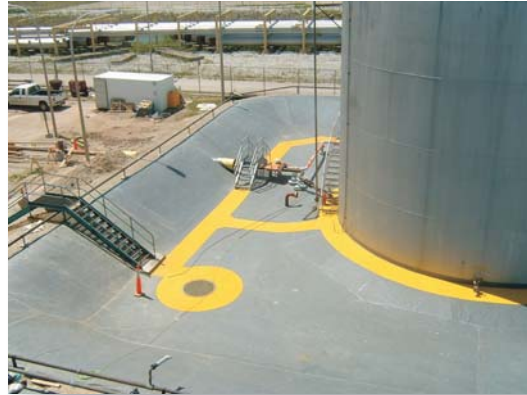
Completed secondary containment membrane

The material chosen for the secondary containment membrane was CSL Silicones' Si-COAT 549 RSM, which consists of a pure organosiloxane resin applied to a geosynthetic backer cloth. This system has outstanding chemical & UV resistance, and excellent stability in extreme temperatures. Thus, no overburden is required, allowing ease of membrane inspection and spill clean-up.

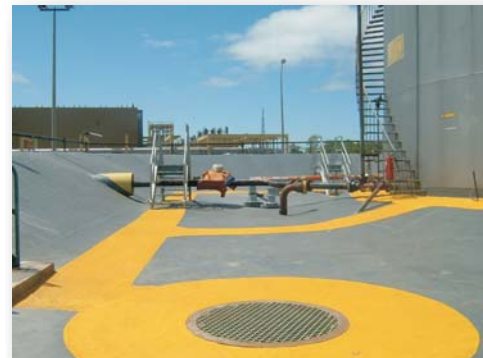
Concrete sump and pedestrian walkway

The project was awarded to Inscan Contractors based on their previous experience in nuclear facilities and a proposal that, although not the least expensive, met all of the needs of the client. Inscan's scope of work included regrading the containment areas and earthen berms, installation of concrete drainage sumps, installation of a secondary containment membrane around the tanks, and application of an FRP leak-detection membrane inside the tanks.
